DEPARTMENT OF FISH AND WILDLIFE

November 22, 2022

CALIFORNIA DEPARTMENT OF FISH AND WILDLIFE NOTICE TO STATE WATER RESOURCES CONTROL BOARD REGARDING 2022 MERCED RIVER CONDITIONS

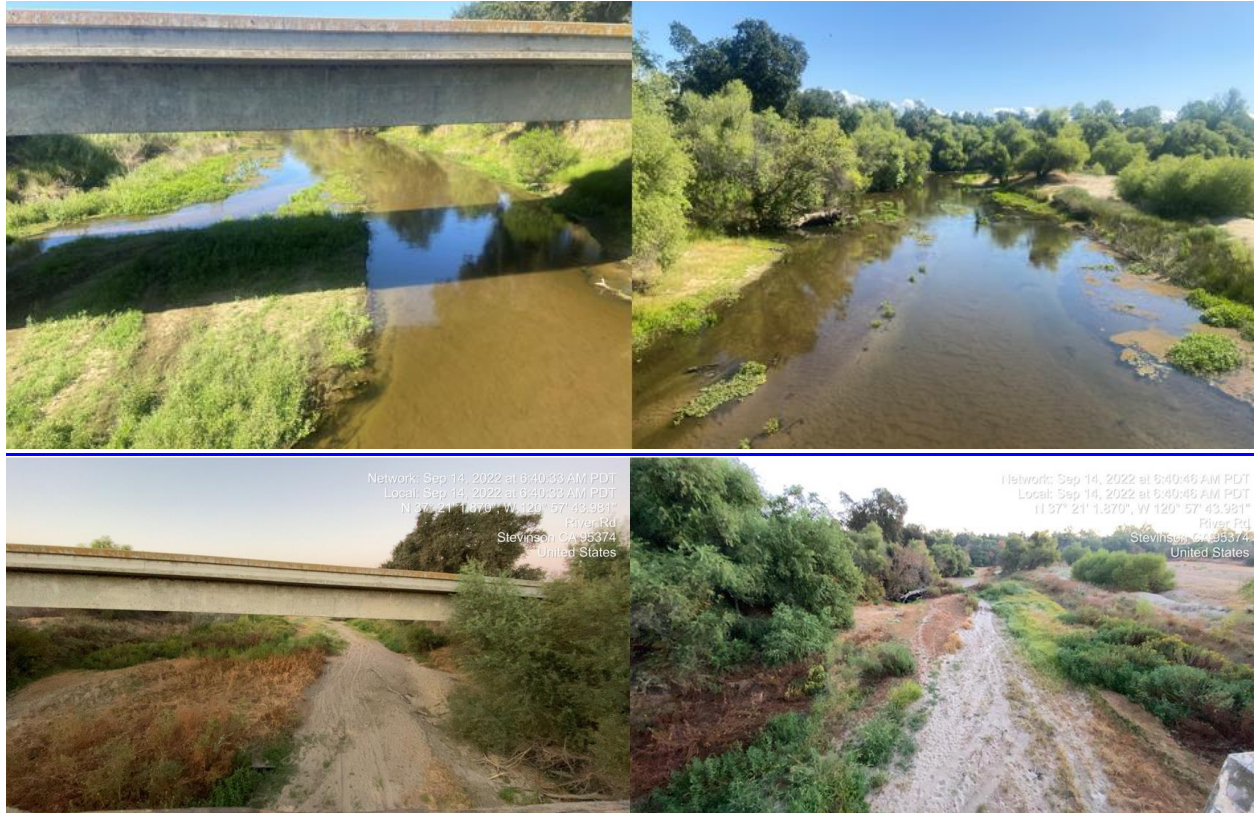
habitat (CRWCB 2019). All these beneficial uses require flowing water in the stream. In addition, for the Merced River to provide a migration corridor for warm-water or cold-water fishes, it needs to hydraulically connect to the San Joaquin River with enough water depth for fish to pass upstream which was not the case during the summer of 2022 (Figure 3).

Figure 3. Photographs taken from Hatfield Bridge (RM 2.5) on May 5, 2022 (top) September 14, 2022 (bottom). Left photo is looking downstream, right photo is looking upstream.

We recommend the SWRCB investigate and address the factors contributing to the unusable conditions in the lower Merced River for native fish and wildlife and find solutions to avoid similar conditions in the future.
